Home Inspection Report

1019 Wensleydale, El Centro , CA 92243

Friday, February 10, 2017

Home Pro Inspections

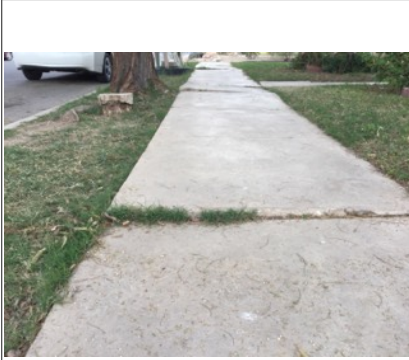
This is a potential trip hazard. I
 recommend repair.
 Multiple locations.

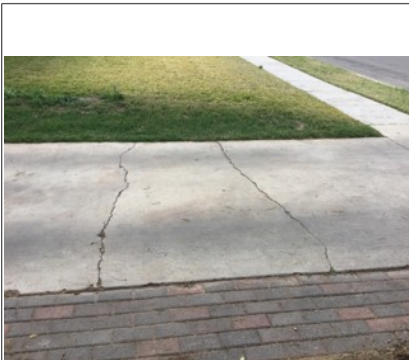
Surface crack noted that does not
 appear to be structural. Cement
 may crack due to thermal
 expansion.

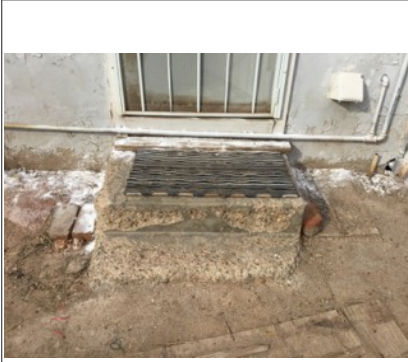
South steps are crumbling. I recommend repair by a qualified tradesman.

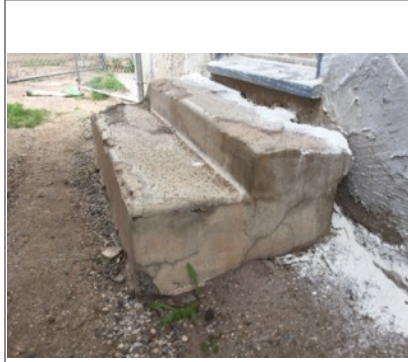
South. Uneven steps. This is a potential trip hazard. I recommend repair.

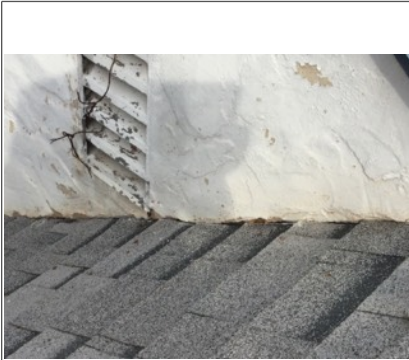
No flashing visible.

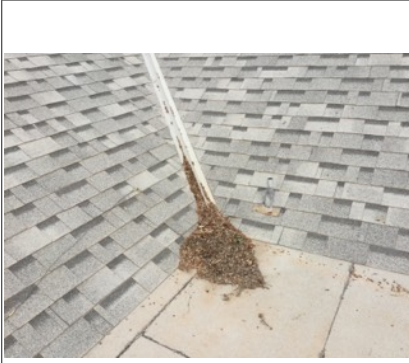
The roof valley should be cleaned in order to function correctly. A build up of debris could lead to water damage.

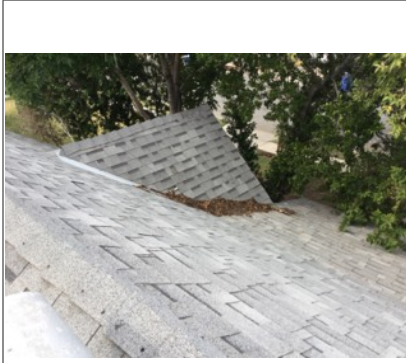
The roof valley should be cleaned in order to function correctly. A build up of debris could lead to water damage.

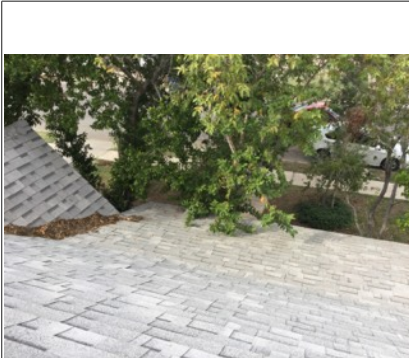
Trees may damage roofing when they are in contact. I recommend trimming the trees away from the home.

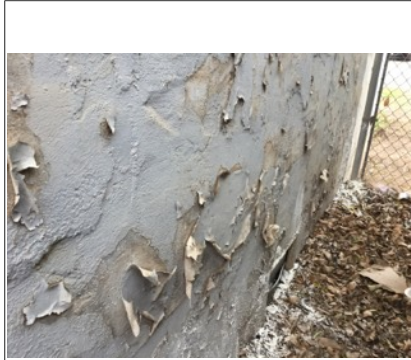
East. The paint is losing its adhesion and starting to peel. I recommend scraping and painting.

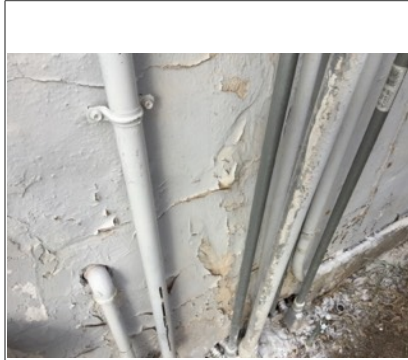
South. The paint is losing its adhesion and starting to peel. I recommend scraping and painting.

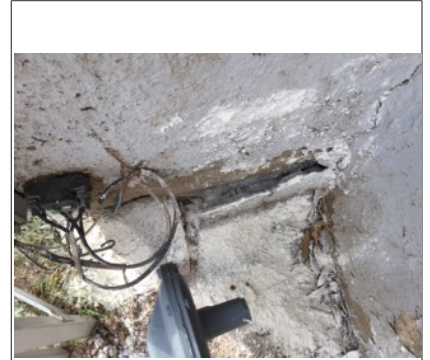
Stucco is falling off. I recommend repair by a qualified tradesman. South

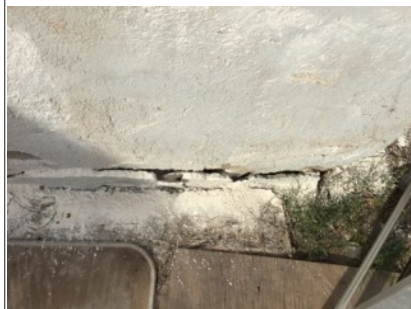
Stucco is falling off. I recommend repair by a qualified tradesman. West

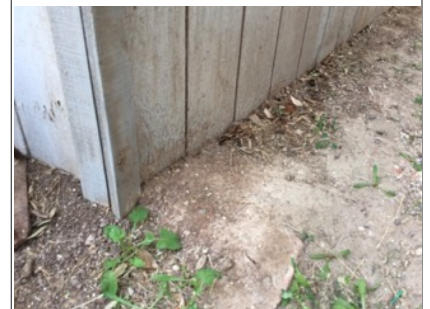
Storage. There is earth to wood contact here. This can cause wood rot and provide a pathway for termites.

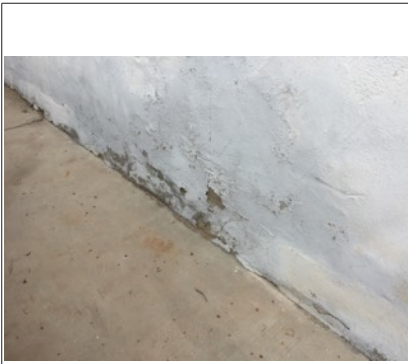
West The paint is losing its adhesion and starting to peel. I recommend scraping and painting.

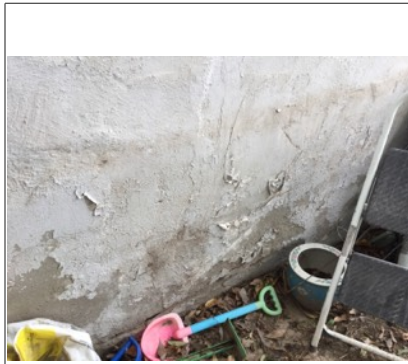
North. The paint is losing its adhesion and starting to peel. I recommend scraping and painting.

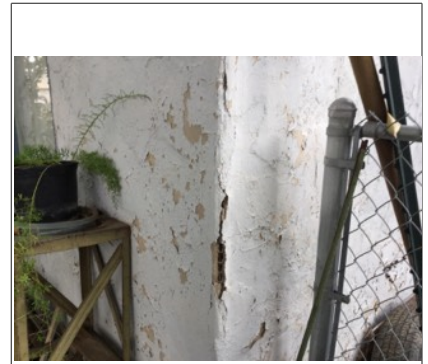
Stucco repair needed NW corner.

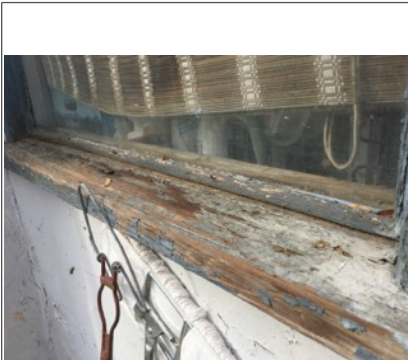
South. The paint is losing its adhesion and starting to peel. I recommend scraping and painting.

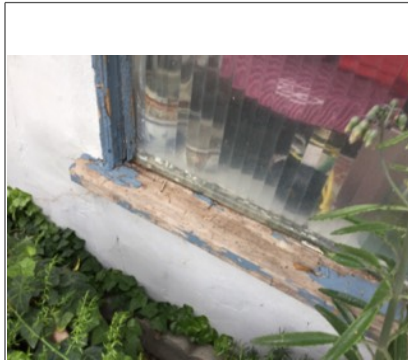
North. The paint is losing its adhesion and starting to peel. I recommend scraping and painting.

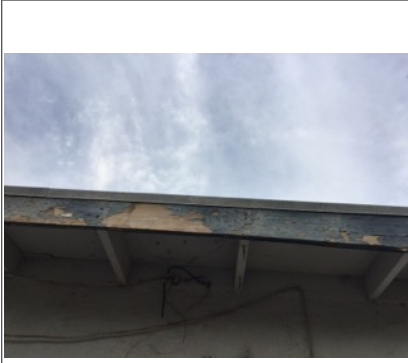
South. The paint is losing its adhesion and starting to peel. I recommend scraping and painting.

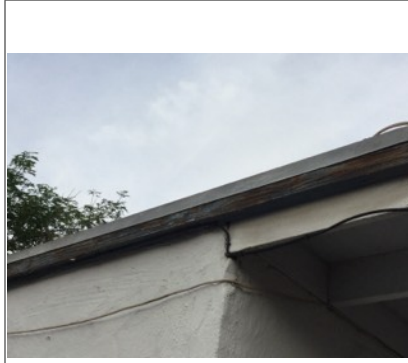
West. The paint is losing its adhesion and starting to peel. I recommend scraping and painting.

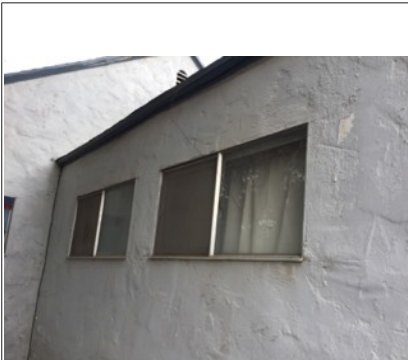
The windows are single pane metal. Metal windows typically transfer heat more than wooden or vinyl windows.

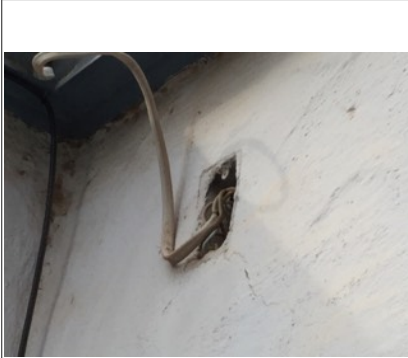
SE. Exposed wiring. Potential for shock or electrocution. This is a safety hazard.

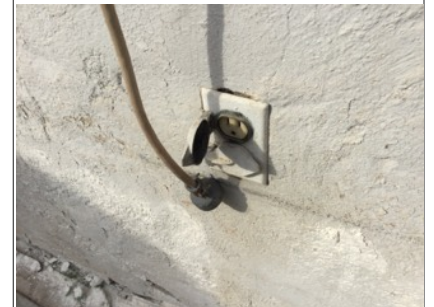
South. This receptacle is lacking GFCI protection. This is a safety hazard. GFCI protects against shock. For maximum safety use GFCI receptacles in any potentially wet area.

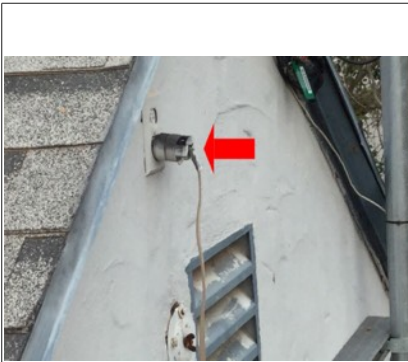
South. There is handyman wiring that is unsafe. This is a safety hazard. I recommend having a licensed electrician further evaluate the wiring.

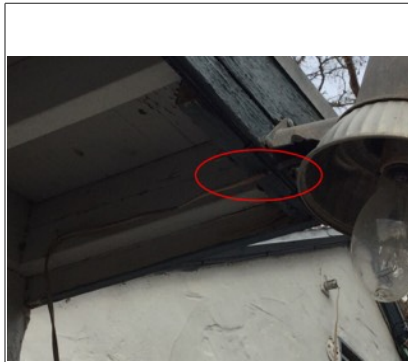
South. There is handyman wiring that is unsafe. This is a safety hazard. I recommend having a licensed electrician further evaluate the wiring.

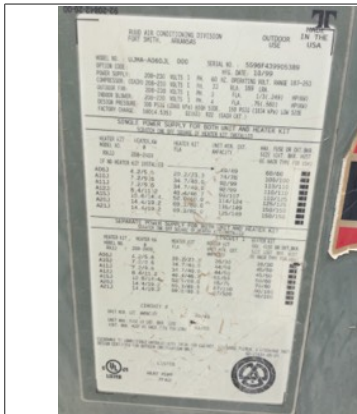
Rudd, 5 ton, 1999, Maximum breaker allowed is: 60 a

AC breaker 50 a. Ok
AC is not grounded. The ground wire is there to prevent shock and maintain safety. This is a safety hazard.

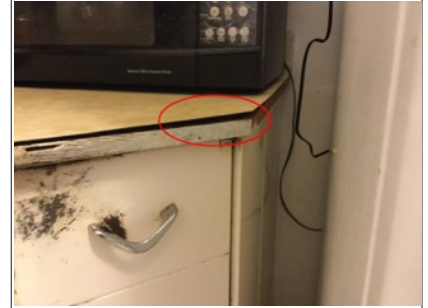
Counter has damage

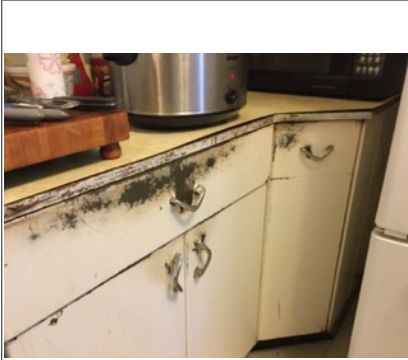
Damage. Old and worn

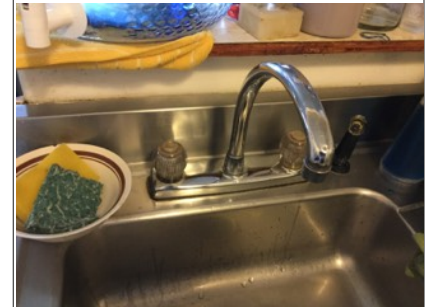
Faucet does not function well. Have to turn to just the right spot to shut off.

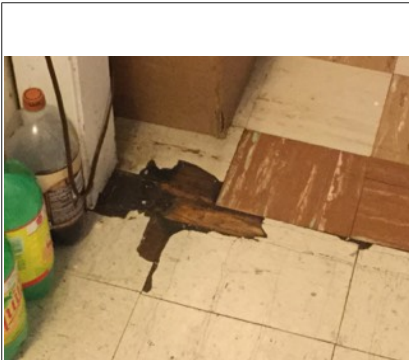
Floor has damage.

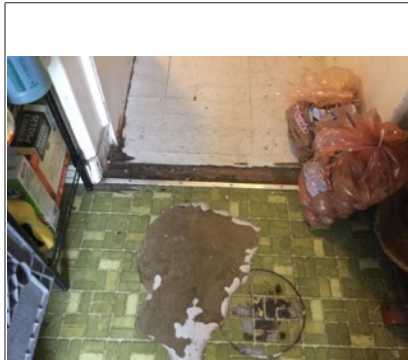
Floor damage.

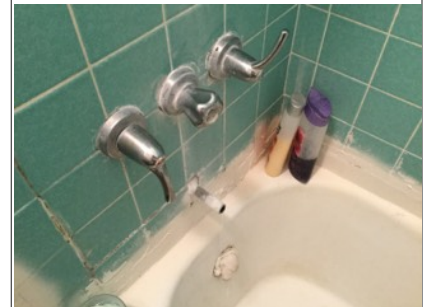
Valve and spout need repairs.

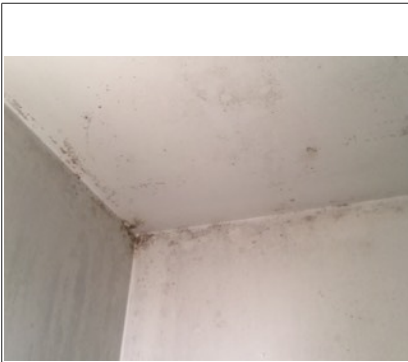
Ceiling and wall are discolored. I recommend more ventilation.

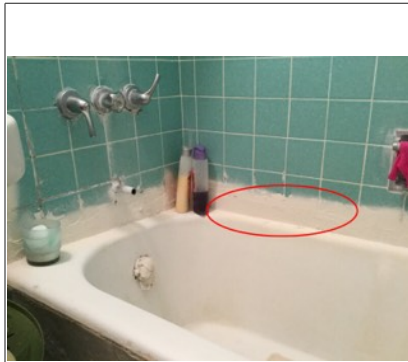
Bathtub has sank and is not level. I recommend repair by a qualified tradesman.

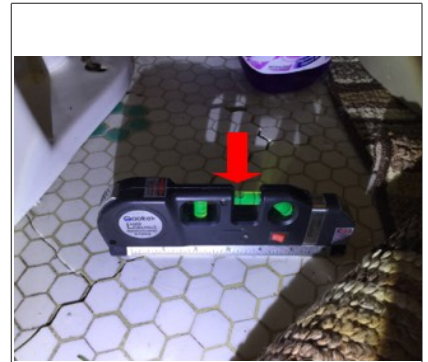
Floor is not level. I recommend repair by a qualified tradesman.

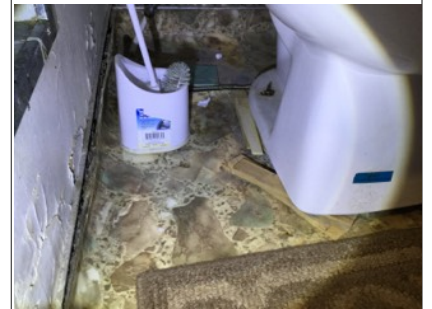
Toilet is loose. Floor is curling and damaged.. Signs of water leaks. I recommend that you contact a licensed contractor for further evaluation.

I recommend that you contact a licensed contractor for further evaluation of the floor and plumbing.

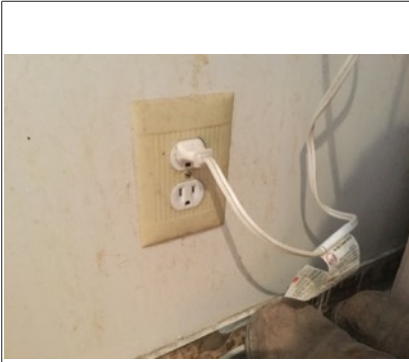
This receptacle is lacking GFCI protection. This is a safety hazard. GFCI protects against shock. For maximum safety use GFCI receptacles in any potentially wet area.

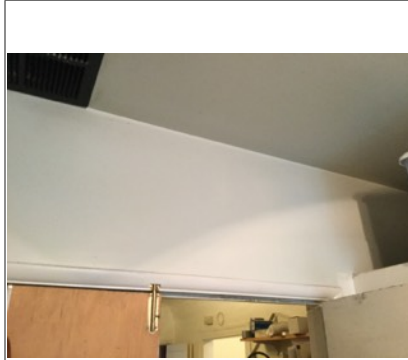
This bedroom is lacking a smoke sensor. Every bedroom needs a working smoke sensor. This is a safety hazard.

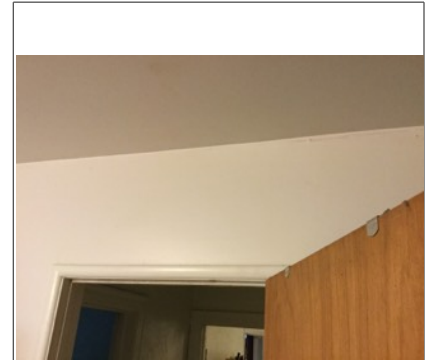
This bedroom is lacking a smoke sensor. Every bedroom needs a working smoke sensor. This is a safety hazard.

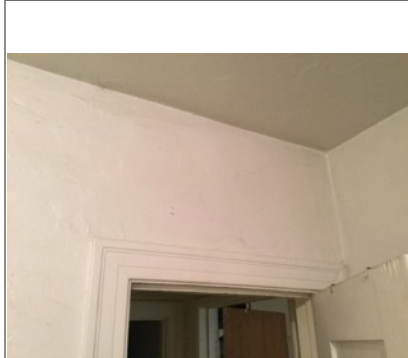
This bedroom is lacking a smoke sensor. Every bedroom needs a working smoke sensor. This is a safety hazard.

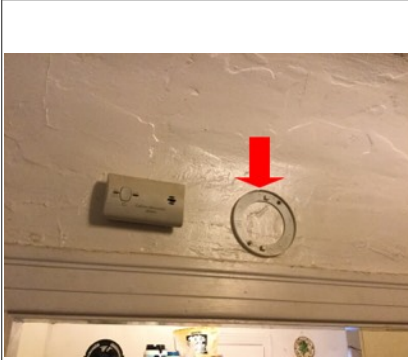
CO sensor is present and working. No smoke sensor. This is a safety hazard.

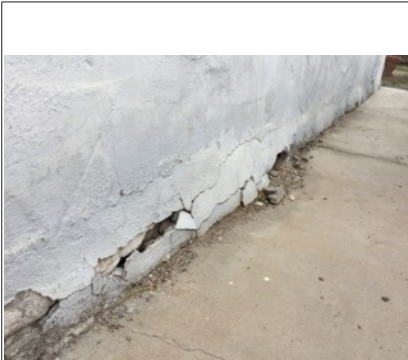
West wall exterior. Degradation of the exterior. I recommend that you contact a licensed contractor for further evaluation.

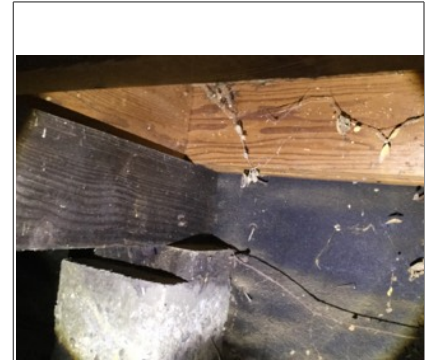
East side. No perimeter wall.

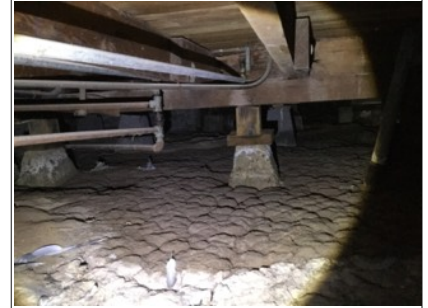
Large areas of mud under the home. Concrete piers are subbing up the water and they may need to be re-leveled. It is very important to stop the leaking in order to preserve the integrity of the home.

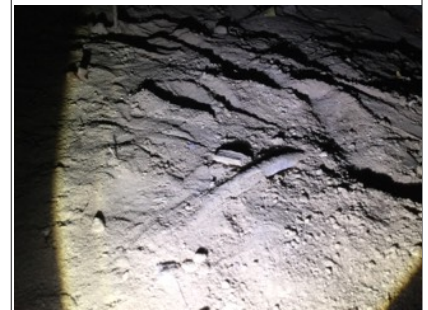
Electrical wire in the soil. This is a safety hazard.

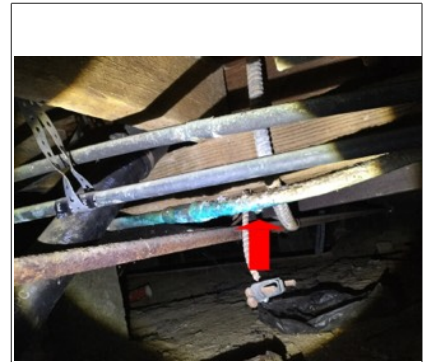
Water dripping from compromised copper pipe. This is only a small leak problem.

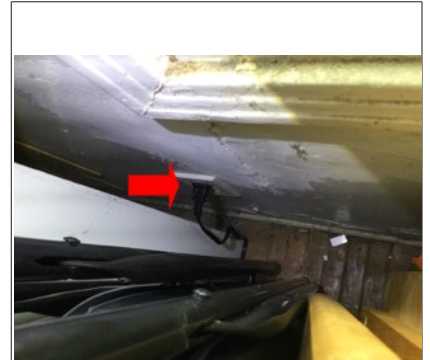
This is the old style receptacle with only two prongs and no ground. This is a safety hazard.
