Home Inspection Report

1019 Wensleydale, El Centro , CA 92243

Friday, February 10, 2017

Home Pro Inspections

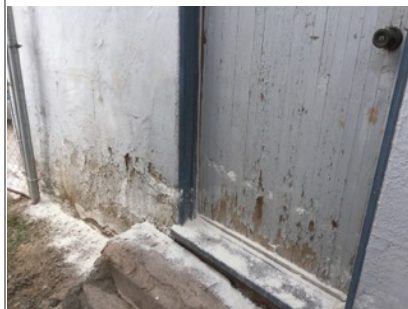
SW. Door and siding. The paint is losing its adhesion and starting to peel. I recommend scraping and painting.

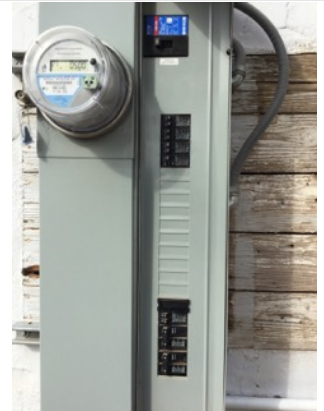
The electrical panel is not labeled adequately. Labeling is important to be able to use the panel safely and quickly in the case of an emergency.

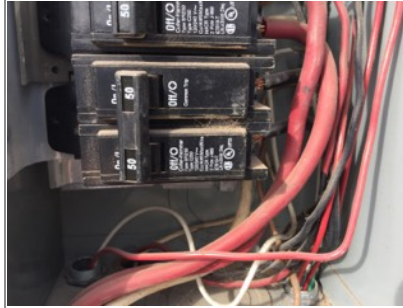
AC breaker 50 a. Ok
AC is not grounded. The ground wire is there to prevent shock and maintain safety. This is a safety hazard.

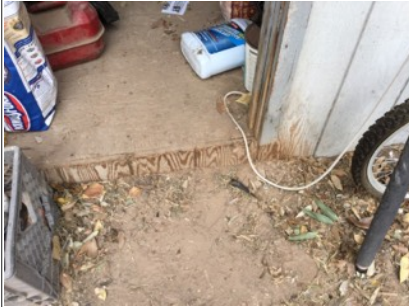
There is earth to wood contact here. This can cause wood rot and provide a pathway for termites.

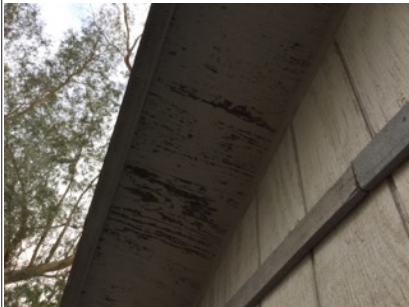
Eave The paint is losing its adhesion and starting to peel. I recommend scraping and painting.

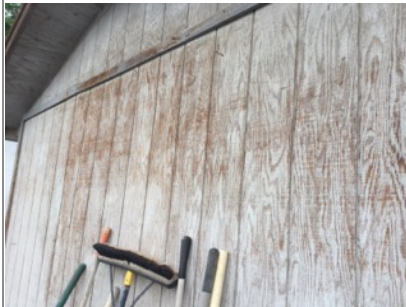
Siding. The paint is losing its adhesion and starting to peel. I recommend scraping and painting.

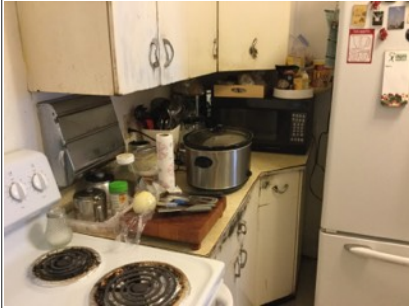
Counters are damaged. Old and worn

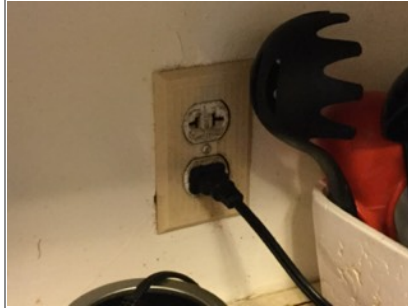
This is the old style receptacle with only two prongs and no ground. This is a safety hazard.

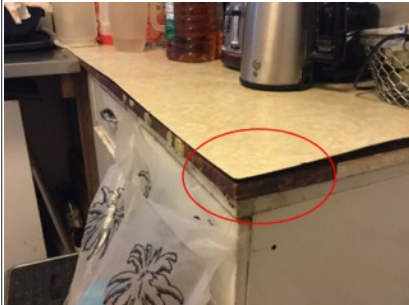
Counter has damage

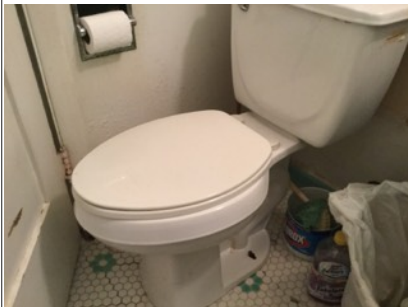
Toilet is loose. Floor has damage.

Comments I recommend that you contact a licensed contractor for further evaluation of the floor and plumbing.

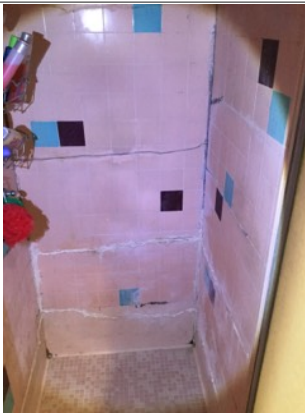
Shower tile is cracked in multiple areas. Floor is soft next to shower. I recommend that you contact a licensed contractor for further evaluation.

Comments I recommend that you contact a licensed contractor for further evaluation of the floor and plumbing.

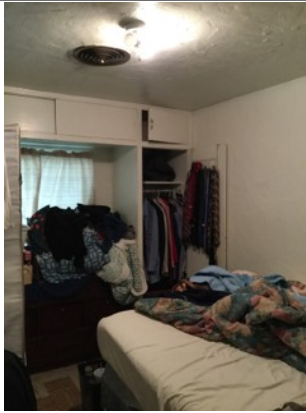
No fan. Window does not open. This window could restrict egress during a fire. This is a safety hazard.

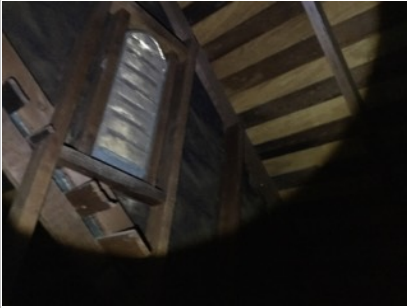
West. This is a gable vent. This is where the hot air in the attic is vented outside.

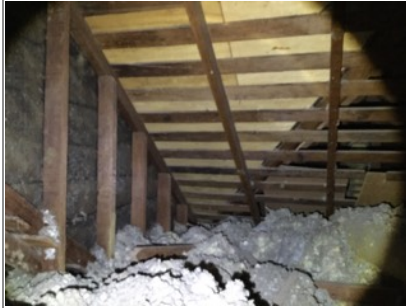
This is a view of the attic structure. It is important that the structural members are intact to support the weight of the roof. No defects noted in this picture.

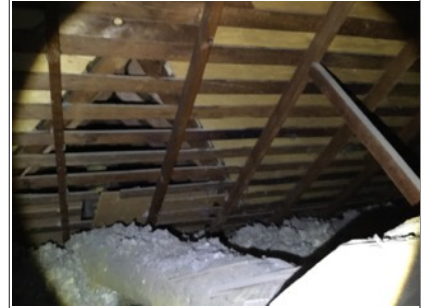
This is a view of the attic structure. It is important that the structural members are intact to support the weight of the roof. No defects noted in this picture.

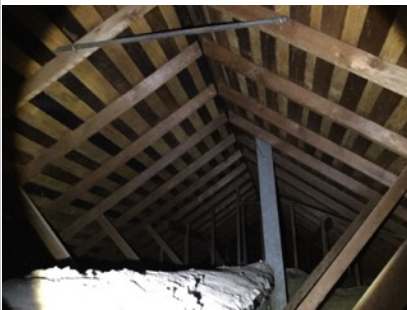
This is a view of the attic structure. It is important that the structural members are intact to support the weight of the roof. No defects noted in this picture.

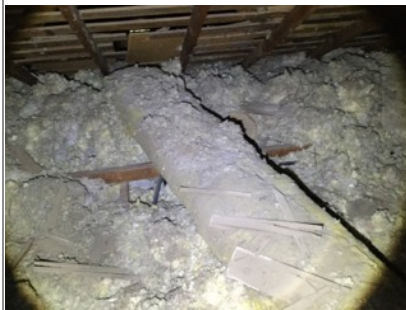
View of the attic structure, AC ducts, and ceiling insulation. No defects noted in this picture.

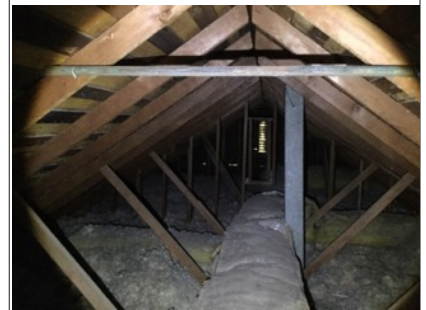
This is a view of the attic structure. It is important that the structural members are intact to support the weight of the roof. No defects noted in this picture.

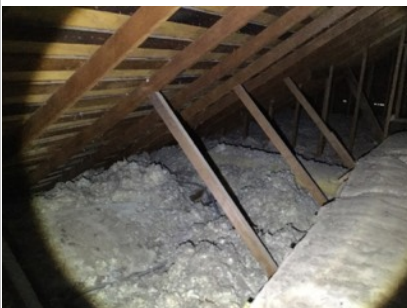
This is a view of the attic structure. It is important that the structural members are intact to support the weight of the roof. No defects noted in this picture.

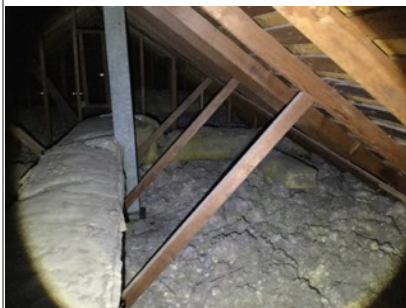
View of the attic structure, AC ducts, and ceiling insulation. No defects noted in this picture.

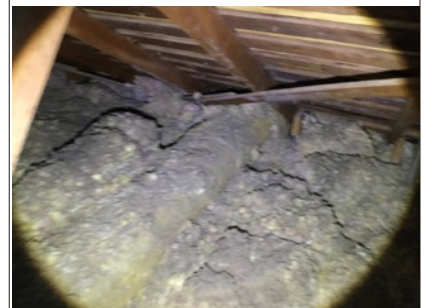
View of the attic structure, AC ducts, and ceiling insulation. No defects noted in this picture.

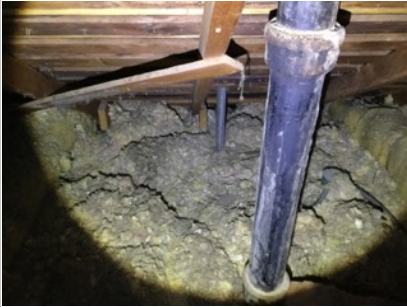
View of an interior vent passing through the attic to the exterior. This is the correct method to vent. No defects noted in this picture.

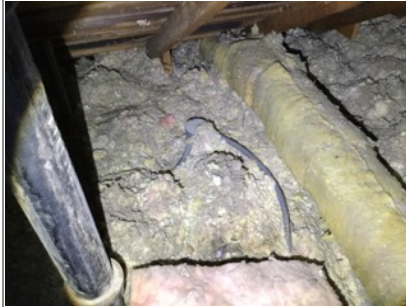
View of the attic structure, AC ducts, and ceiling insulation. No defects noted in this picture.

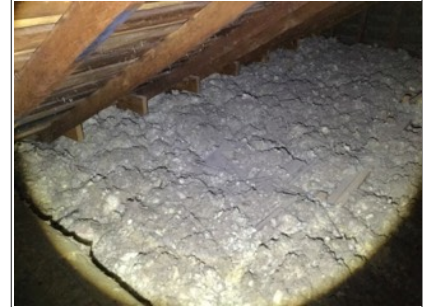
Attic insulation. No defects are noted in this picture.

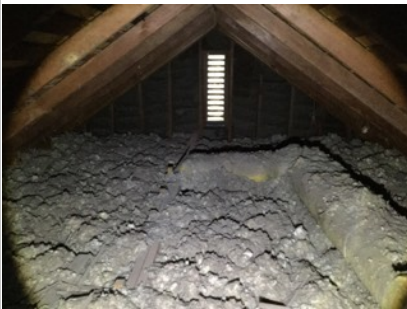
East. This is a gable vent. This is where the hot air in the attic is vented outside.

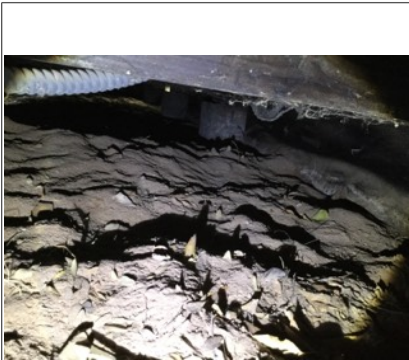
Dirt floor.

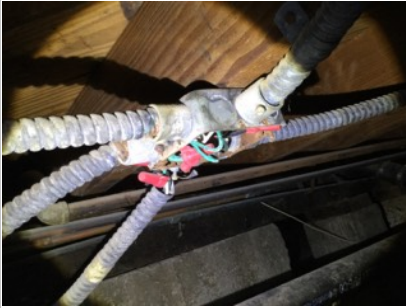
Exposed wiring. Potential for shock or electrocution. This is a safety hazard.

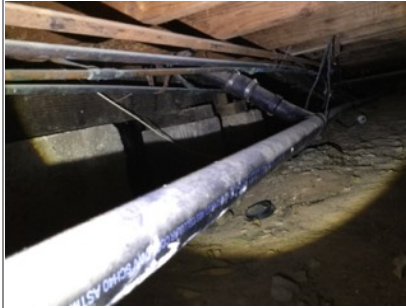
Newer ABS plastic pipe drain. No defects are noted in this picture.

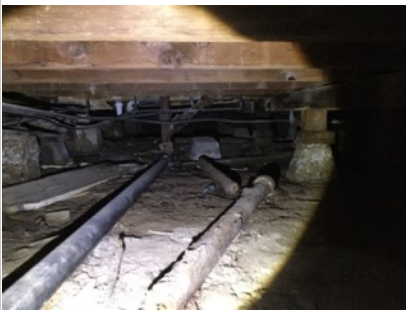
Looking west at another large area of mud. The west and south areas of the crawlspace were inaccessible due to mud and potentially live wires.

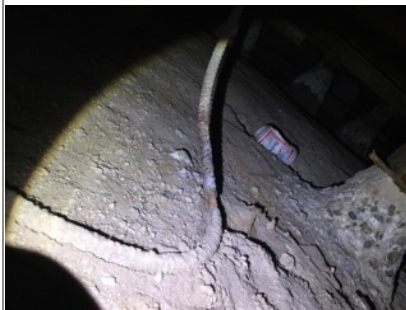
Corroded electrical wire in the soil. This is a safety hazard.

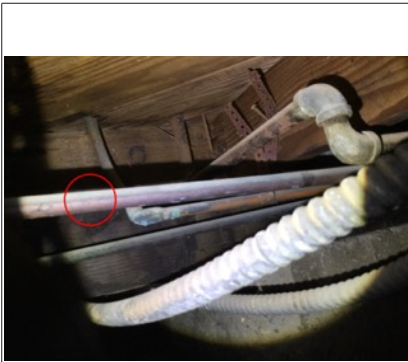
Newer copper pipe.

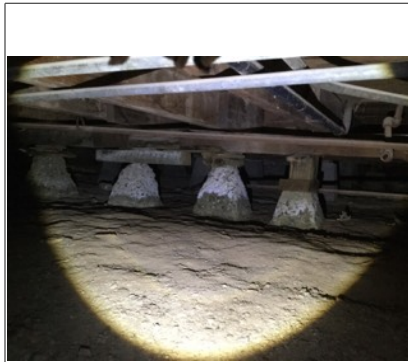
Another area of wet and eroding piers.

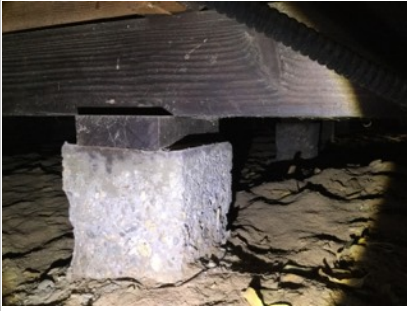
The home rests on concrete piers.

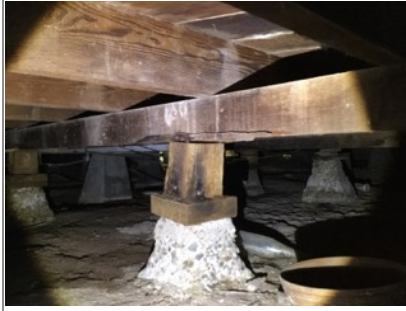
Concrete pier in one of the wet zones. It is eroding.

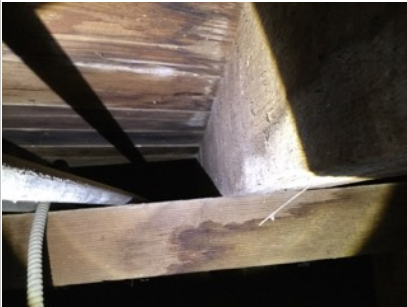
View of girder, floor joist, and subfloor. No defects are noted in this picture.

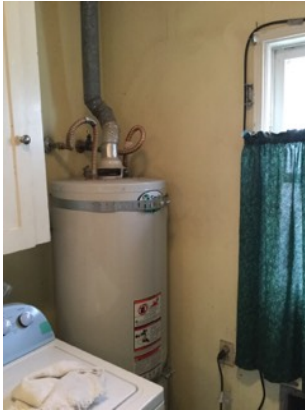
In laundry. No defects are noted in this picture.

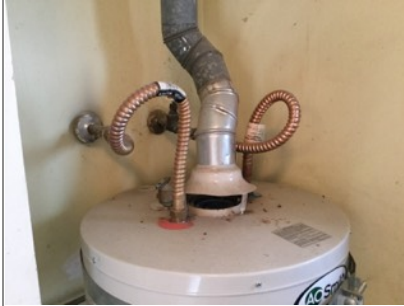
View of the top connections of the water heater. No defects are noted in this picture.

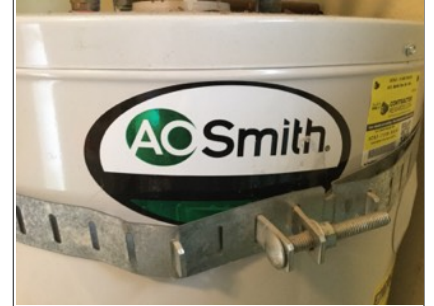
Make of the unit.

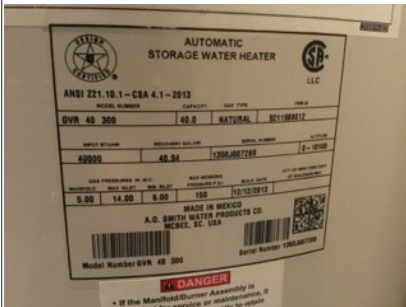
A O Smith, 40 gallons, gas, 2014

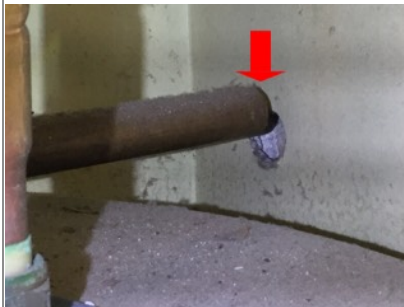
The water heater is lacking an adequate drain pipe for the Pressure/Temperature Relief valve. For optimum safety, install a correct drain pipe.

The drain was never connected.
